DEFERRED MAINTENANCE: The Unknown Cost

By Dave Gross / Gross Inspection Services / Brookfield

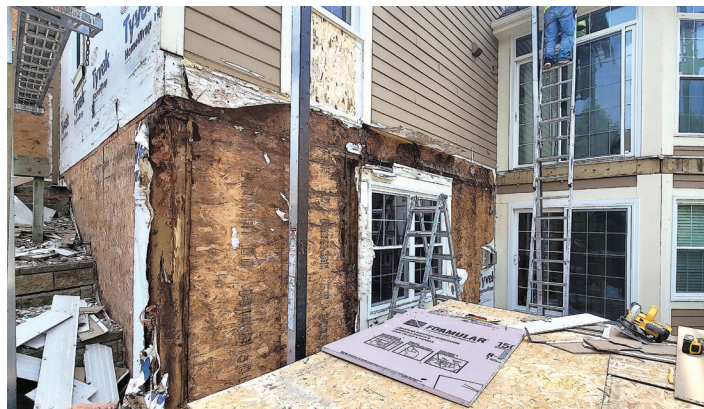
Hidden water damage behind siding and door edges for last 22 yrs.

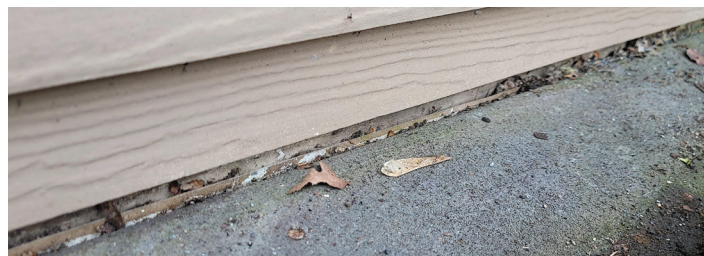
Improperly installed ledger flashing for a deck

Clients then wanted to correct the rest of the exterior properly. The exterior inspection led to many discoveries. The roof was original and had failed at the peak. Roof was replaced and gutters updated. What will all this actually cost? Great question, there was a range for the roofing and gutter quotes. The final cost was \$35,000.00. All windows and doors are being replaced for \$70,000.00. New LP siding and trim \$60,000.00. Concrete replacement where it settled at the patio, driveway and stairs \$21,000.00. Deck removal and install to meet code \$30,000.00

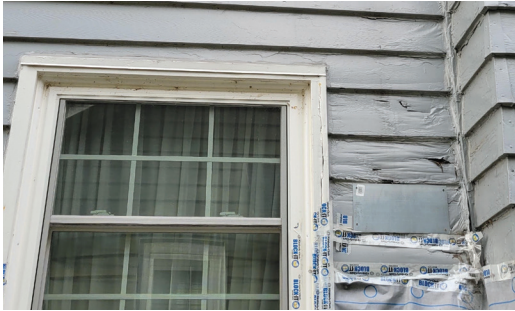
Damage from water and ice penetration since added addition

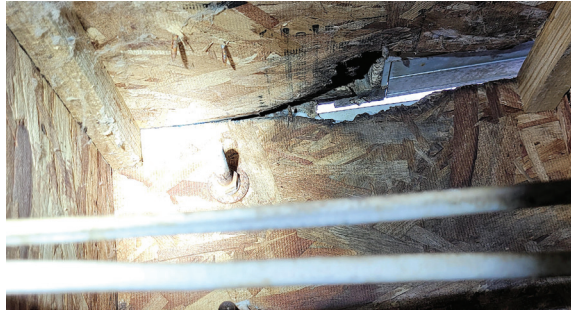
An unusual amount of cold air was blowing through this joist space. I then scanned to the exterior of the house and found another thermal anomaly. The ceiling was cut open, a snow drift had accumulated in the basement ceiling above the drywall. The opening in the ceiling revealed a hole in the sheathing and rotted flooring under the back door to the deck. This hole had allowed the wind and snow to blow into the house. The deck flashing at the house to the ledger board was not properly tied into the house wrap and siding. The main door had no flashing and gaps under it. This directed the water behind the ledger board, which rotted out the sheathing of the house. The leak was further enhanced by water being driven or sucked into the house.

Inside basement upward view of failed sheathing and flooring underneath door

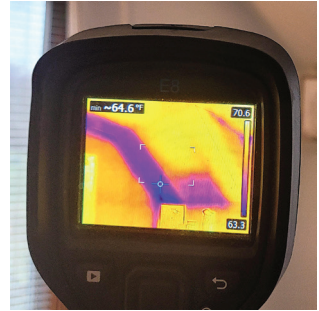
Thermal imaging reveals lack of insulation in cathedral ceiling

An upgrade for the inspection is to use thermal imaging. A trained thermographer inspecting a house after a rainstorm will help identify the areas of concerns. These areas would be where attention should be placed for repairs. Wet materials have different heat capacities and show up differently in the infrared spectrum. Having a temperature difference from inside to outside of 9°F is recommended for the best results while completing a scan.
